Case Study

Manchester Airport Hotspot Repairs

Location	Manchester Airport
Client	Bethell & Manchester Airport Group (MAG)
Project Value	£150,000
Project Timeline	Four weeks

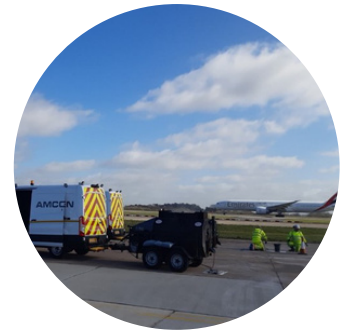
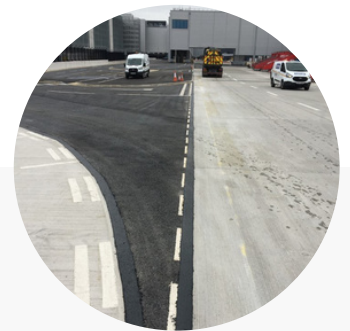
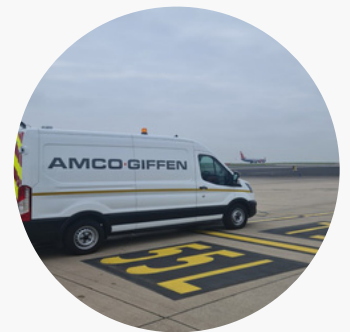
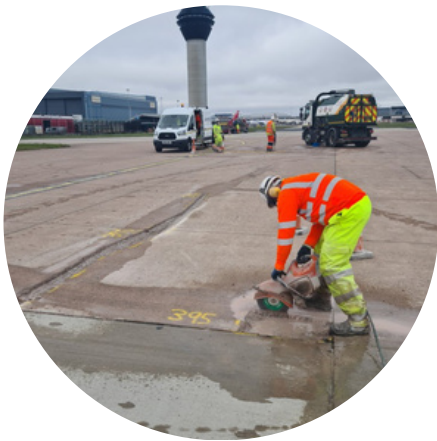
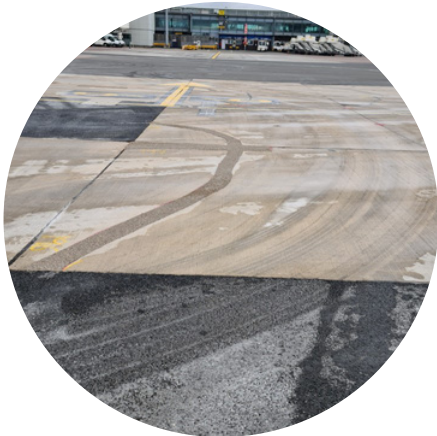
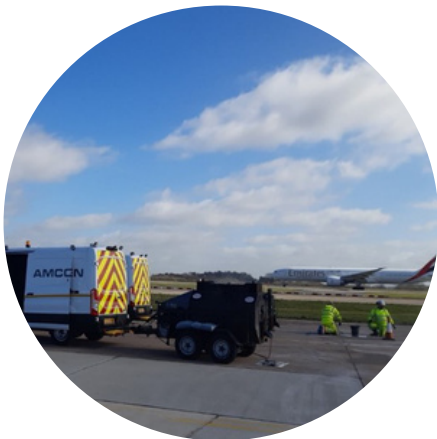
For the hotspots (totalling 217m²), we used a 350 road planer on large repairs, milling out the centre section and then saw-cutting the edges to give the repairs a clean, straight edge. Smaller repairs were saw-cut and broken out using Hilti breakers. We then cleaned the repairs with a road sweeper, before jet-washing them down. After drying (using a gas torch), primer was applied before Maxicrete 40 grade was added and left to cool for 30 minutes. A second layer of (20 grade) Maxicrete was then added, with bauxite stone applied on top to complete the repair.

We also had to complete six bay replacements during night-time possessions. This involved removing the concrete bays above services (eg fuel mains, electricity, fire hydrants), but doing so by saw-cutting them into manageable sections and lifting them off (rather than the usual concrete-breaking and removal with an excavator), to avoid any damage to the buried services. Once all the defective concrete had been removed, the sub-base was inspected and, if necessary, replaced. The new PQX concrete was then poured using volumetric wagons until flush with the existing concrete bays.
