Design Team Case Study

South Tyne Viaduct Strengthening and Refurbishment

End Client	Network Rail
Design Stages	Approval in principle to as-built
BIM	BIM Stage 1
Specialist Software	2D AutoCAD

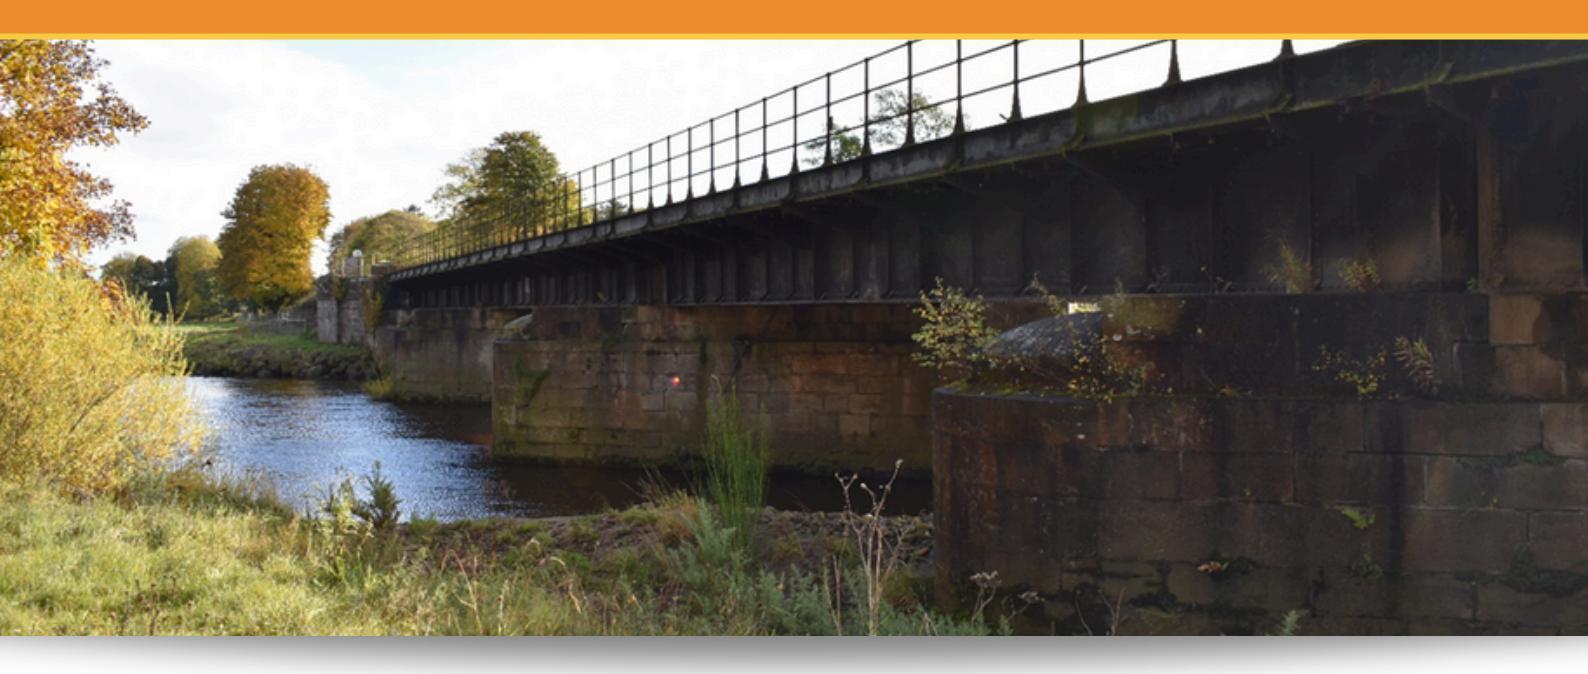
South Tyne Viaduct carries two tracks over the River South Tyne, over five spans and is located between Haydon Bridge and Bardon Mill Stations in Northumberland.

Each of the five spans is of similar deck type construction, consisting of four riveted steel plate girders positioned directly below the rails, and a steel plate supporting the ballasted tracks. The main girders are connected transversely by half-depth steel diaphragm plates. The cantilevered Cess areas on each elevation are supported by steel cantilever brackets with a steel edge beam running along the external face.

Each deck is supported by substructures comprising stone block abutments, wingwalls and four intermediate stone block piers.
